INVESTIGATION OF A FATAL FIRE IN A MOVING VEHICLE

ABSTRACT

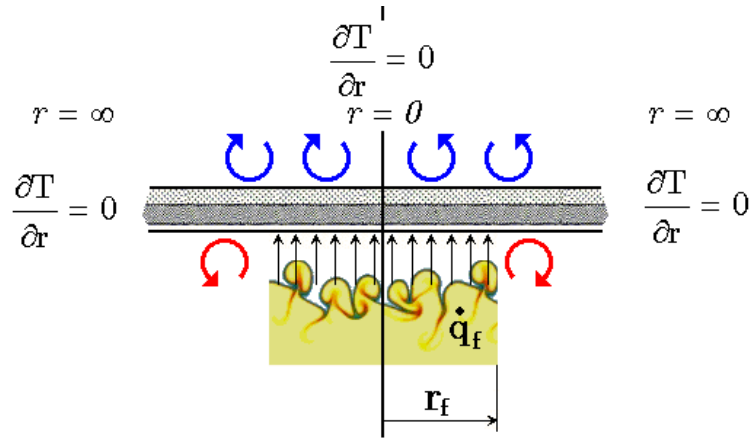
Figure 2. Schematic of the floor heated from below in the thermal model

The transient heating of the floor from the exterior (Fig. 2, left) by a flame on the bottom was modeled to allow calculating the approximate ignition times of the floor-covering materials inside the vehicle. The goal was to assess both the auto ignition and the piloted ignition.

The layered floor (carpet, acrylic and steel) was treated as one layer 2.5-cm thick (according to the manufacturer notes) and with weighted properties taken from [6]. The carpet is modeled a 10 mm thick layer of PP+PE. The polyacrylic layer is 12 mm thick and the steel plate of 2 mm. The flame temperature T_f was assumed to be 900 °C, the emissivity ε to 0.9, the flame radius r_f to 10 cm, the convective heat transfer inside the van h_i to 7 W/mK, and the convective heat transfer outside h_o (air velocity of 50 km/h) was set to 55 W/mK.

The results (Fig. 2, right) show that the center of hot spot heats up at an initial rate of about 130 °C/min. The heating slows down significantly after reaching 300 °C and reaches steady state temperature (450 °C) after about 600 s. A typical auto-ignition temperature for carpet material is about 600 °C [1], so the calculations predict that auto ignition of the floor-covering will not take place. If a pilot source is present in the vicinity (holes in the floor) and assuming a piloted ignition temperature of carpet of 400 °C [1], ignition would occur 380 s after flame exposure started. These results are later compared to experimentally measured temperature profiles (Figs. 5 and 6).

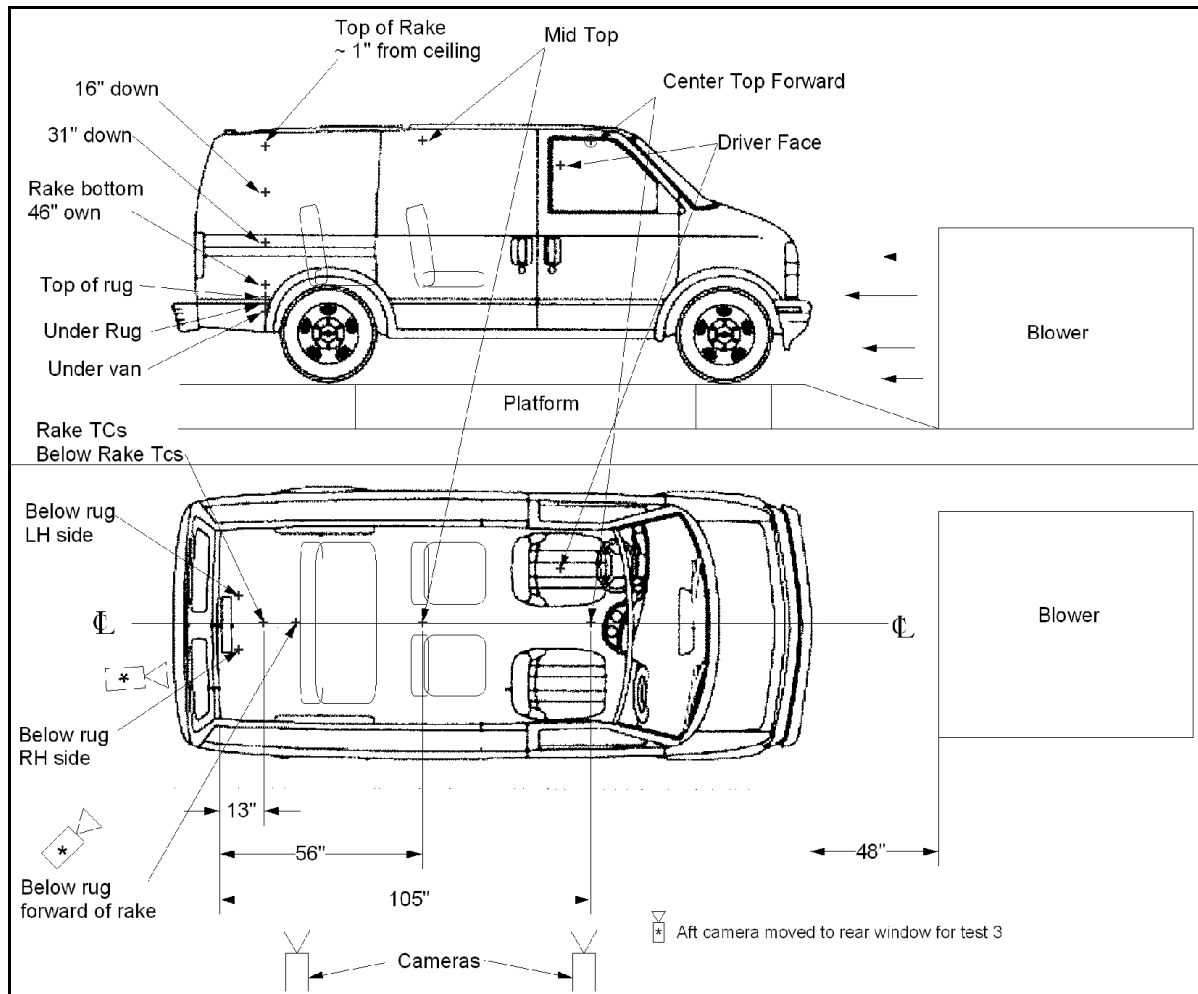
Figure 4. Location of thermocouples inside the vehicle for the full scale tests.

Each test was instrumented using thermocouples and video cameras. Fig. 4 is a schematic of the test set-up showing location of the measurement locations. The instruments were placed at selected locations throughout the inside and outside of the vehicle, with more measurement points right above the area of fire impingement (note vertical rake with thermocouple at the rear). Results from the FDS model were used to help determine the best location of the thermocouples and the video cameras. A thermocouple in front of the nozzle recorded flame duration and ambient conditions were also recorded. Gas measurements of the interior atmosphere at the driver position were taken during each test using acetaldehyde and acrolein sensitive Dreager tubes. The threshold detection level of these tubes was 10 ppm. These measurements were made to see if these common irritant gasses, produced during degradation of plastic materials, could alerting the passengers to the impending fire. The spray nozzle was located under the van next to the alleged degraded fuel line. The nozzle was pointed so that the center of the spray pattern contacted the under floor pan aft of the rear axle. There was only one exemplar van of this vintage available for the tests. Consequently, we needed to be frugal with the floor covering materials, the head liner and the seats so that we had enough virgin materials to conduct three tests. Thus the termination requirement for all but the last test was to stop the experiment when flames spread to the
